# Arborist Report

## Tree Preservation Plan – William Hawrelak Park

Development Permit No: 426720802-002

**RE: Tree Preservation Plan – William Hawrelak Park  
(Project No: ECN 6.1. 2023)**

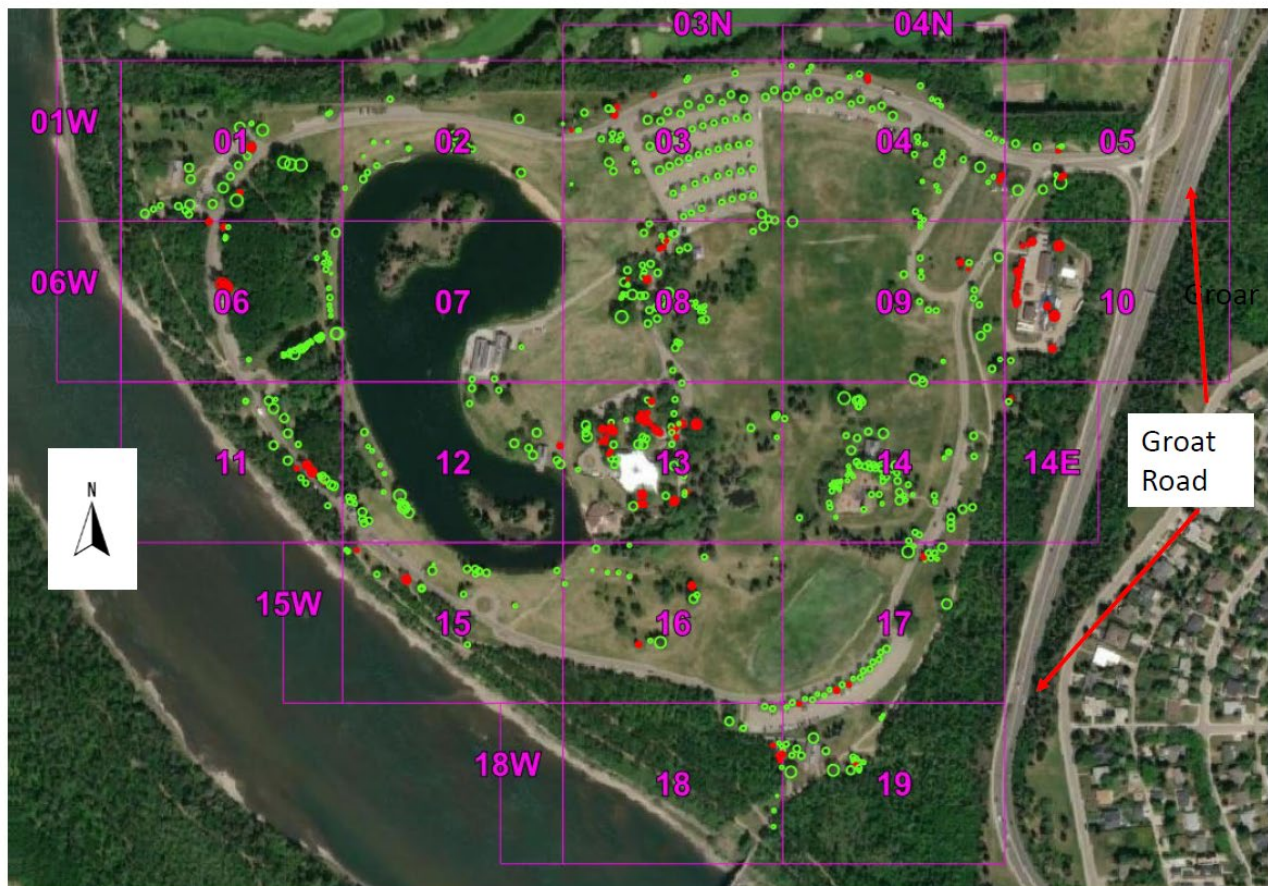
**Figure 1. Hawrelak Park – Development Site.**

The purpose of this report is to inventory locations and tree information from site observations of City of Edmonton trees within William Hawrelak Park (Figure 1). Recommendations for trees are consistent with tree preservation requirements in the Public Tree Bylaw 18825, and the associated June 2022 Tree Preservation Guidelines. This tree preservation plan has been requested by the City of Edmonton in support of Development Permit application 426720802-002.

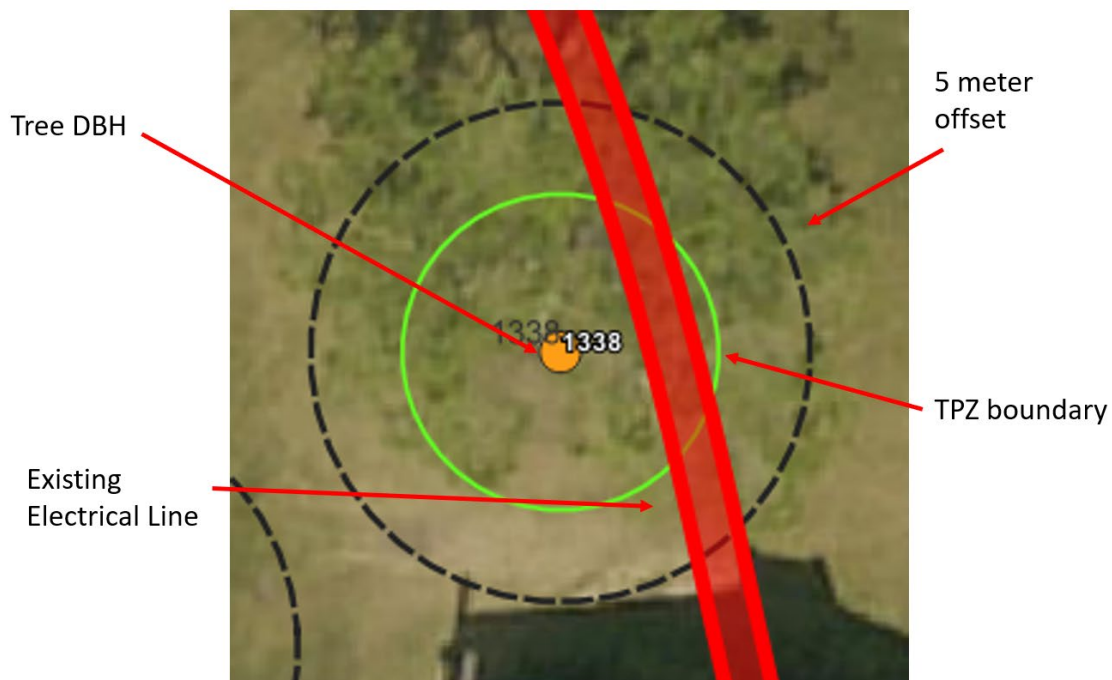
**Figure 3. Example of GIS Utility Overlay for Identifying Conflicts.**

A GIS buffer tool was utilized to generate a 5 m tree protection zone (TPZ) radius polygon around each individual tree in open spaces. Construction plans for new utilities or infrastructure overlapping these individual tree buffers (**Figure 3**) triggers recommendations for tree assessment, protection, or removal.

This preservation plan will only address those “planned disturbances” that fall within the identified TPZ using **Table 5** minimum protection distance multipliers.

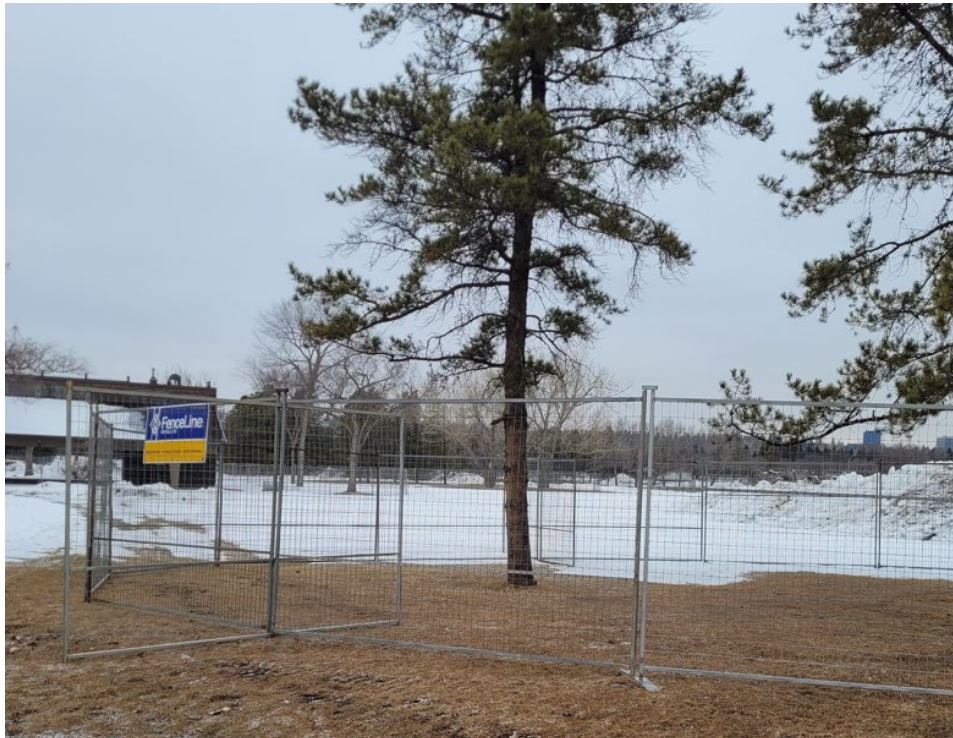
**Figure 4. Metal Fencing Design for Open Space Trees and Natural Area Perimeter.**

- viii. Metal fencing (**Figure 4**) is being used until soil conditions allow for more permanent anchoring.

- ix. There will be no breaks in the fencing as this will provide compaction avoidance.
- x. Fencing posts should be installed in the ground for the duration of the construction period
